Application of NDT Thermographic Imaging of Aerospace Structures

Abstract. This work aims to address the effectiveness and challenges of Non-Destructive Testing (NDT) inspection and improve the detection of defects without causing damage to the material or operator. It focuses on two types of NDT methods; pulsed thermography and vibrothermography. The paper also explores the possibility of performing automated aerial inspection using an unmanned aerial vehicle (UAV) provided with a thermographic imaging system. The concept of active thermography is discussed for inspecting aircraft CFRP panels along with the proposal for performing aerial inspection using the UAV for real time inspection. Static NDT results and the further UAV research indicate that the UAV inspection approach could significantly reduce the inspection time, cost, and workload, whilst potentially increasing the probability of detection.

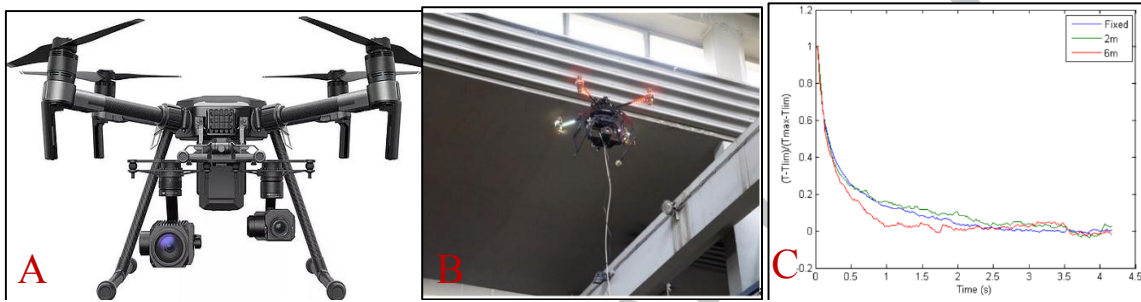
FIGURE 20 A: DJI M210 equipped with thermal camera [27]. **FIGURE 20 B:** UAV equipped with thermal camera [12]. **FIGURE 20 C:** Comparison of front face temperature responses to flash heating in the case of a large uniform irradiation with a fixed camera and a stabilized camera with UAV at two distances (2 m and 6 m) [12] [5].

Along with the liquid penetrant NDT method as mentioned in the introduction, a UAV thermographic inspection was tested for civil engineering applications (see Figure 20B). The UAV is equipped with a FLIR A320, this IR camera is connected to a computer via a cable, one is a power cable and the other provides real time radiometric thermal images, which will reveal heat patterns and thermal anomalies [12]. Transient thermography with flash and step heating where the methods used in this inspection. An inspection took place and gathered data on different distances between the camera and the samples (2, and 6 metres). Along with the UAV equipped with the IR camera, there was a fixed IR camera, therefore two sets of data could be acquired and compared. A thermally uniform area of a sample is delimited, and the IR cameras captured the data [12] [5].
